THE SECTORAL REGIONAL PROGRAM IN THE FIELD OF LOCAL AND REGIONAL ROAD INFRASTRUCTURE FOR UTA GĂGĂUZIA DEVELOPMENT REGION

CORRIDOR # 3

Ciadâr Lunga – Baurci – Congaz - Căetu – Ciselă Mare –
- Chiselă Rusă – M3

Comrat - Chisinau, 2018

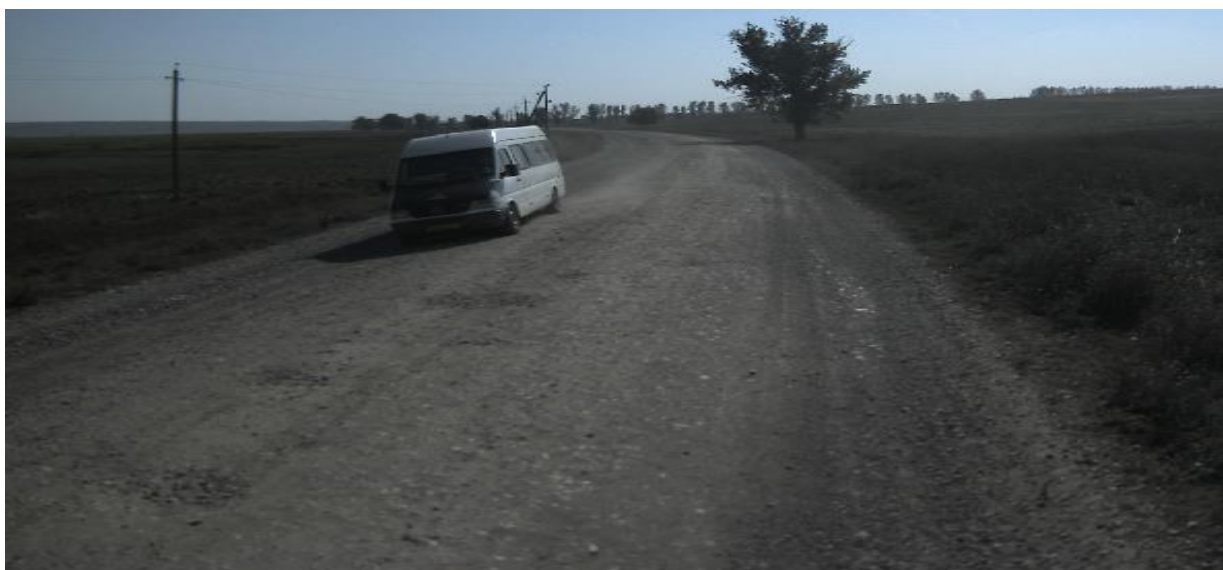
Changing gravel coverage into cement concrete coverage will significantly reduce dust concentration in the 50-100m area of the road. In particular, this will be emphasized in localities, where dust clouds were sitting in the households of the inhabitants.

Figure 5.1.1.1 Dust clouds formation on the gravel roads

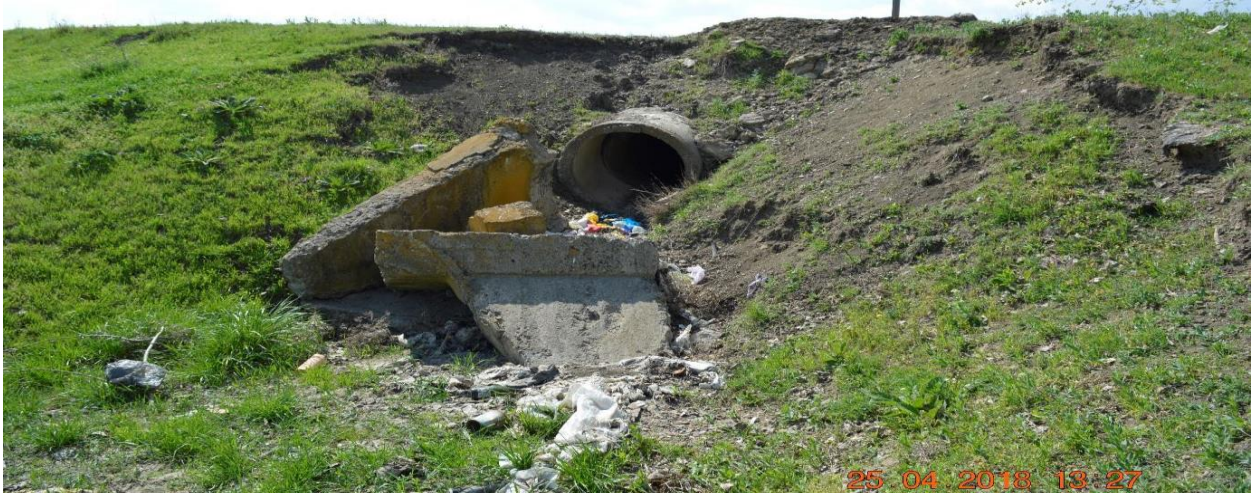
The unsatisfactory level of maintenance of art works has contributed to the erosion of downstream alluviums to some culverts, as well as the mudslide of an essential part of the culverts. This has contributed to the acceleration of the erosion process and the flooding of the neighboring territory.

Due to defects in capture and evacuation systems of rainwater, there are cases of soil erosion with the tendency of forming the ravines, which in the future can lead to the destruction of the road embankment. In the place where are culverts with sludge, there is evidence of the flooding of the adjacent land with the subsequent formation of a sludge layer on the roadside and around it.

Figure 5.1.2.1. Downstream erosion of the culvert with partial degradation of the culvert

There are 7 bridges on the route, 5 of which require mud and shrub cleaning, as well as local repair works and 21 culverts of which 13 culverts require reparation. Expenditures for the cleaning of works of art has been estimated and included in other expenses of the estimations. The proposed solution for art works is shown in Table 7 of Annex 3. The volumes of works for repairing the culvert are shown in Table 6, Annex 3.

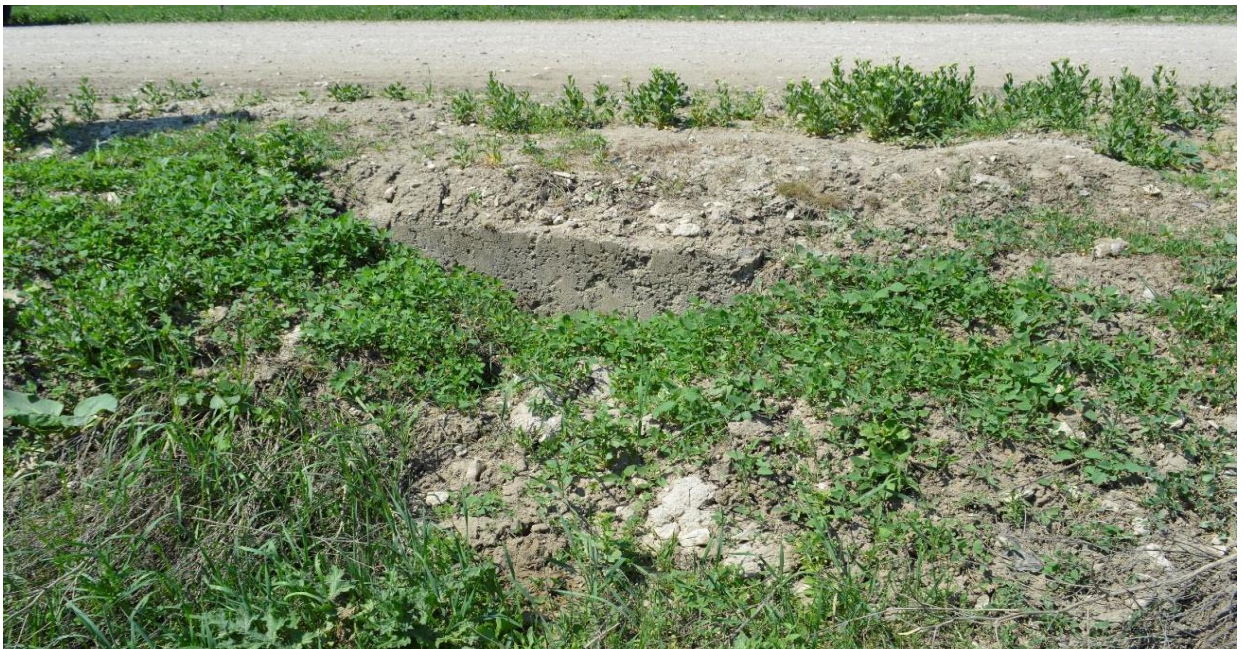
Works of art are represented by 7 bridges with the length of 6 to 60 m and 21 culverts with a diameter from 0.80 m to 2.0 m and from one to three openings, of which 6 (29%) are silted at the level of 20 -100%. Totally silted culverts on km 3,400; 33,07 and 39,875 and 40,009. Entrances and exits to some culverts are crowded with shrubs (km 11.83; 28.30; 31.116; 40,753; etc.), which substantially diminishes the capacity of the culvert. Also, the erosion and the degradation of the consolidations at the exit of the culverts (km 7.10; 9.10; etc.), which represent a threat to the integrity of the embankment. More detailed information on the state of the culverts is provided in Table 3, Annexes 1 and 2.

Figure 5.1.2.2. Silted culvert on km 14,800
