Modernization of local public services in Republic of Moldova

THE SECTORAL REGIONAL PROGRAM IN THE FIELD OF LOCAL AND REGIONAL ROAD INFRASTRUCTURE FOR UTA GĂGĂUZIA DEVELOPMENT REGION

CORRIDOR #1

G125 – Cenac– Dizghingea – Bugeac – R28

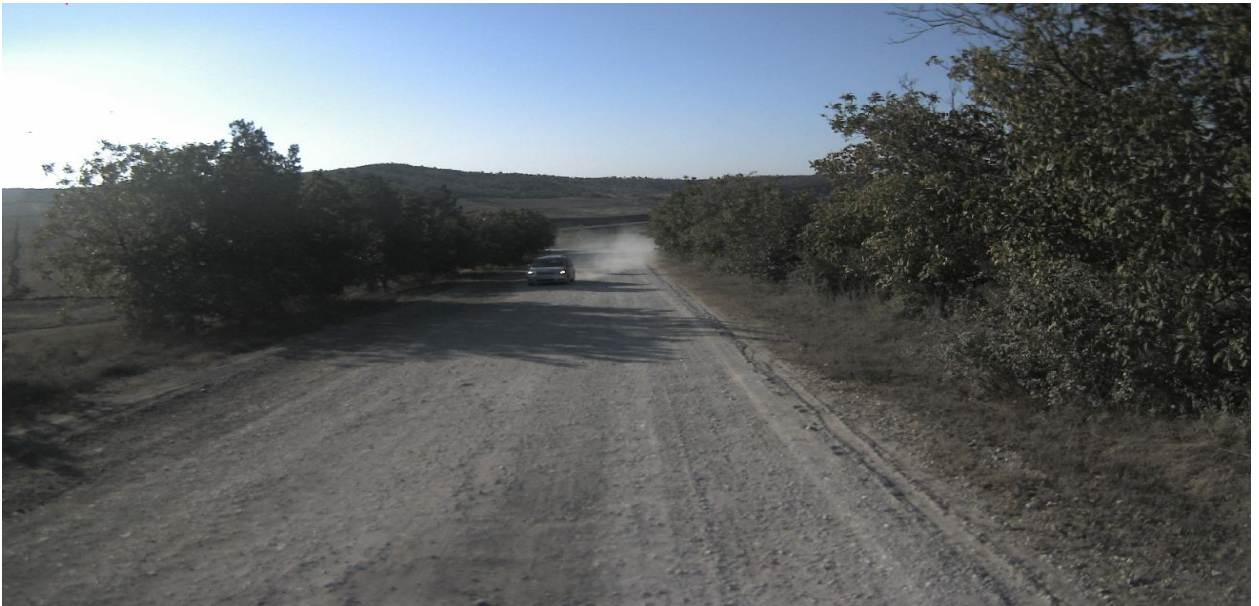
The technical condition of the road essentially influences the environment. Road unevenness (pits, subsidence, etc.) stimulate noise and vibration increase as well as fuel consumption (up to 20%), which increases the amount of harmful emissions in the atmosphere. Roads with gravel coverage are sources of dust, which negatively affect the area around the road (50-100 m). In particular, this is evidenced during the summer, when the plantations are covered with dust, which essentially diminishes the photosynthesis process, thus reducing the harvest of the agricultural crops. It also negatively affects the localities, where dust clouds settle in the households of the inhabitants.

Figure 3.9.1. Dust clouds formation on the gravel roads, km 5+060.

Changing gravel coverage into cement concrete coverage will significantly reduce dust concentration in the 50-100m area of the road. In particular, this will be emphasized in localities, where dust clouds were sitting in the households of the inhabitants.

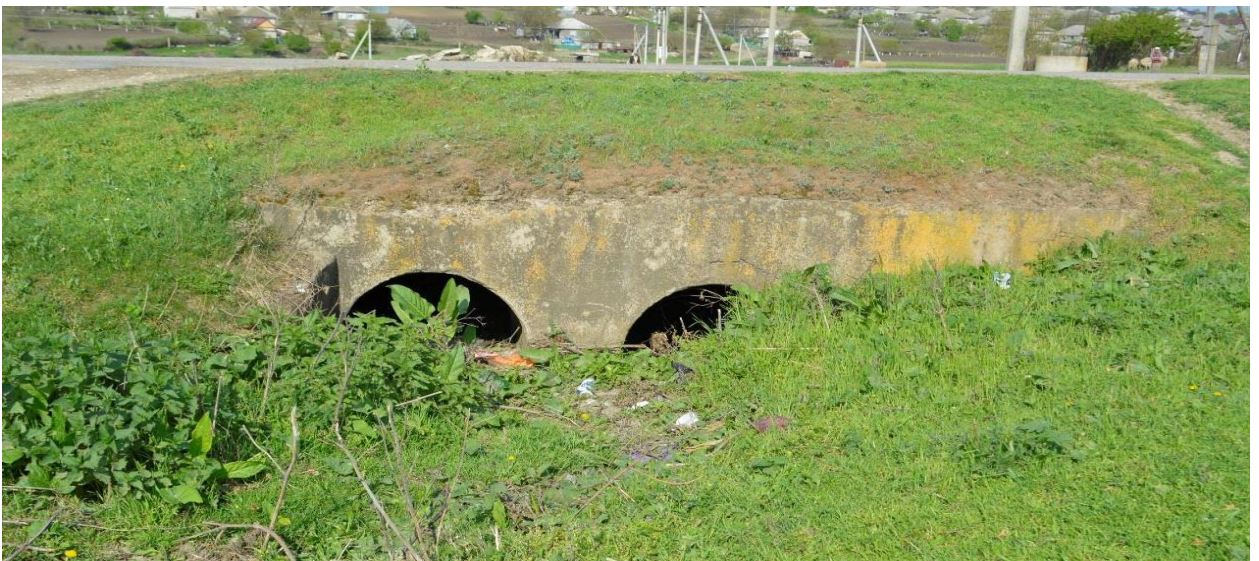
The unsatisfactory level of maintenance of art works has contributed to the erosion of downstream alluviums to some culverts, as well as the mudslide of an essential part of the culverts. This has contributed to the acceleration of the erosion process and the flooding of the neighboring territory.

Figure 3.9.2. Silting an essential part of the culvert, km 7,400

Out of 27 culverts 26 requires reparation. Expenditures for the cleaning of works of art has been estimated and included in other expenses of the estimations. The proposed solution for art works is shown in Table 6, Annex 3.

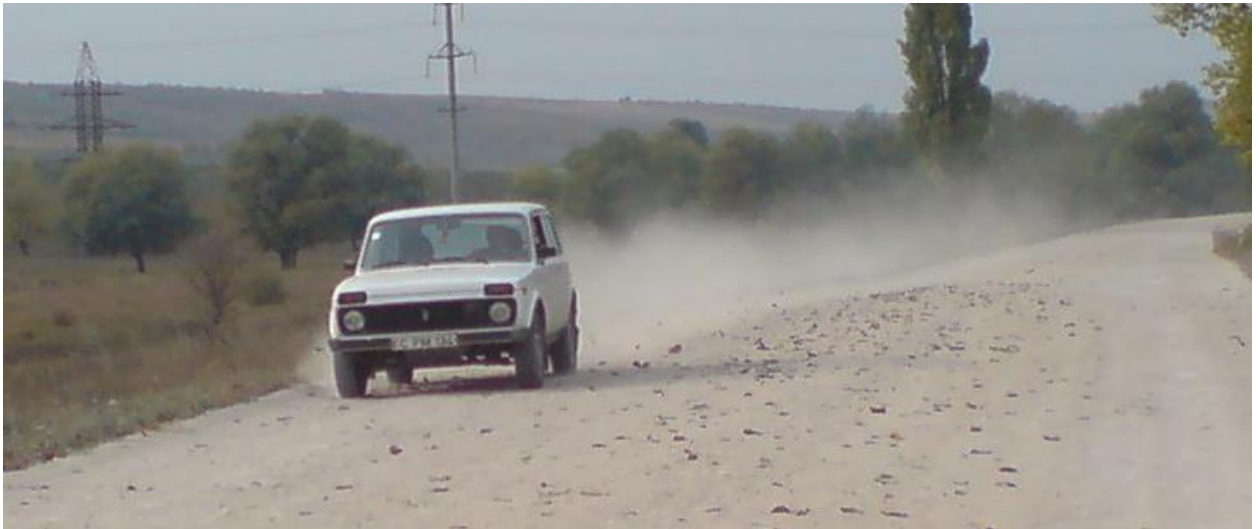
Figure 5.1.1.1 Dust clouds formation on the gravel roads.

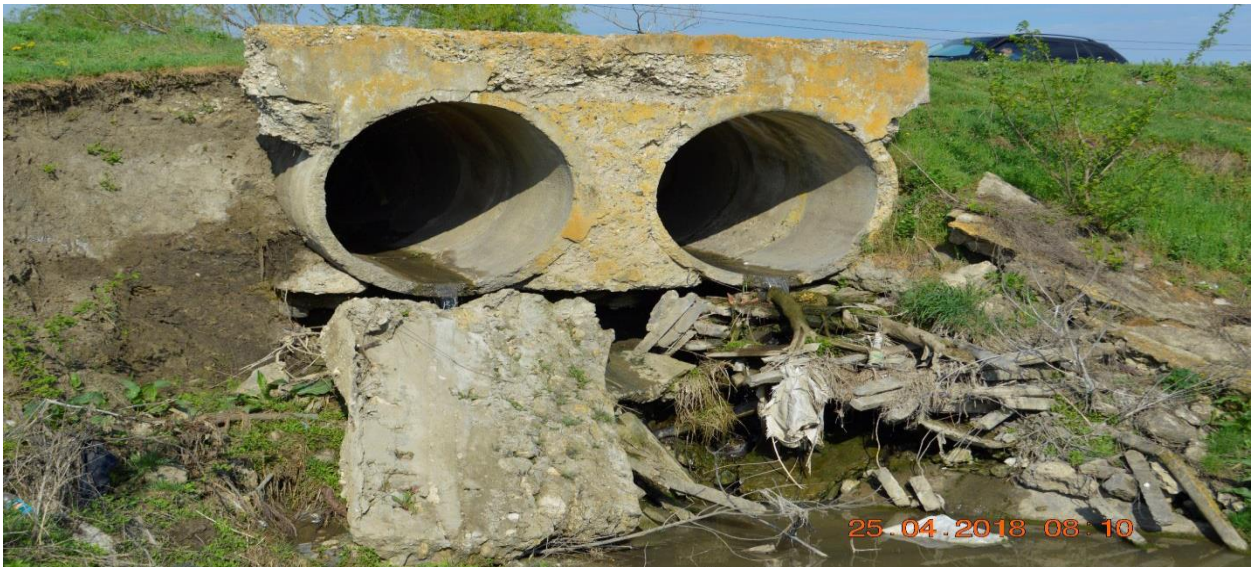
Due to defects in capture and evacuation systems of rainwater, there are cases of soil erosion with the tendency of forming the ravines, which in the future can lead to the destruction of the road embankment. In the place where are culverts with sludge, there is evidence of the flooding of the adjacent land with the subsequent formation of a sludge layer on the roadside and around it.

Figure 5.1.2.1. Downstream erosion of the culvert with partial degradation of the culvert, km 1,80 Corridor I.
