# Modernization of local public services in Republic of Moldova

## THE SECTORAL REGIONAL PROGRAM IN THE FIELD OF LOCAL AND REGIONAL ROAD INFRASTRUCTURE FOR UTA GĂGĂUZIA DEVELOPMENT REGION (2018-2025)

### CORRIDOR # 5

### Vulcănești – Alexandru Ion Cuza – Etulia – Etulia Noua – Cișmichioi – M3

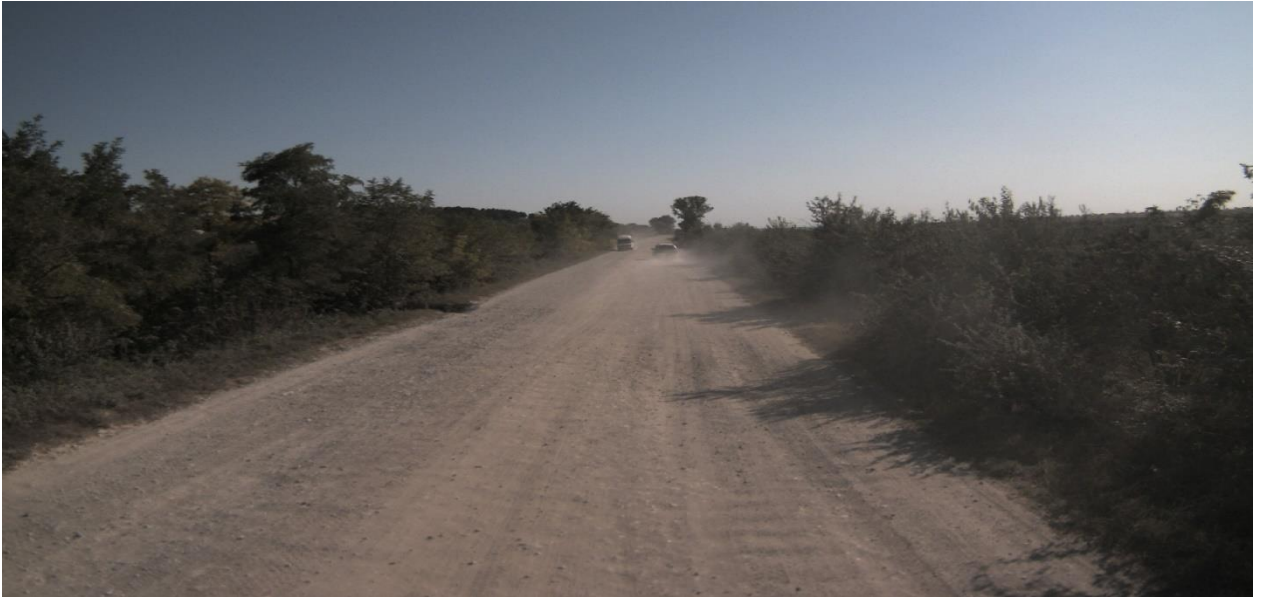
The technical condition of the road essentially influences the environment. Road unevenness (pits, subsidence, etc.) stimulate noise and vibration increase as well as fuel consumption (up to 20%), which increases the amount of harmful emissions in the atmosphere. Roads with gravel coverage are sources of dust, which negatively affect the area around the road (50-100 m). In particular, this is evidenced during the summer, when the plantations are covered with dust, which essentially diminishes the photosynthesis process, thus reducing the harvest of the agricultural crops. It also negatively affects the localities, where dust clouds settle in the households of the inhabitants

Figure 3.9.1 Dust clouds formation on the gravel roads.

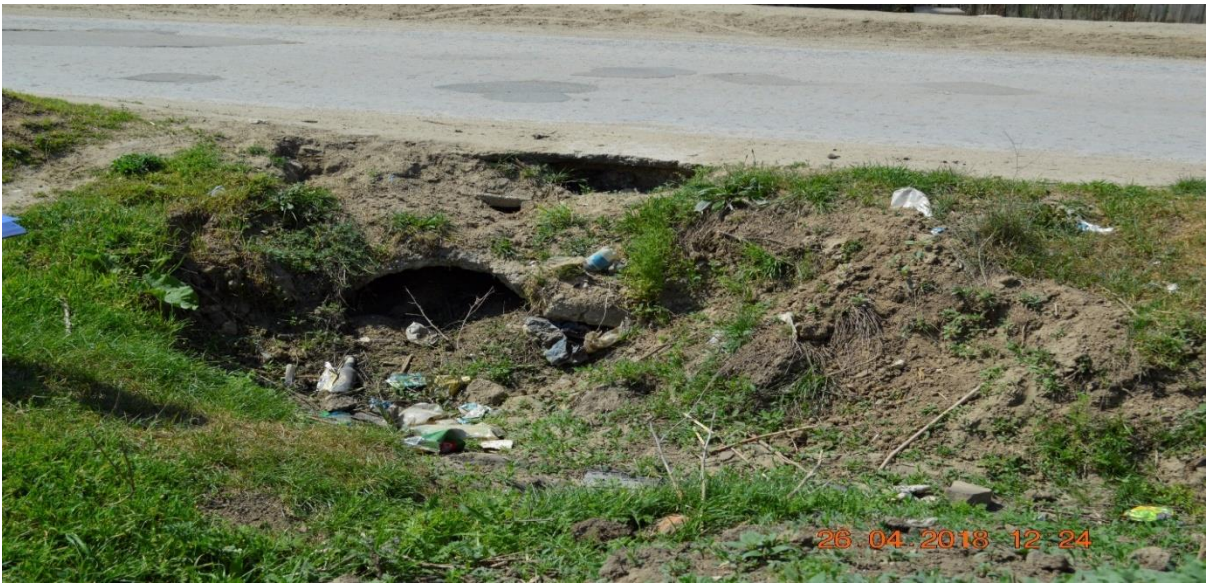
The unsatisfactory level of maintenance of art works has contributed to the erosion of downstream alluviums to some culverts, as well as the mudslide of an essential part of the culverts. This has contributed to the acceleration of the erosion process and the flooding of the neighboring territory.

Figure 3.9.2. Silting an essential part of the culvert on km 13,400.

There are 7 bridges on the route, which require mud and shrub cleaning, as well as local repair works and 22 culverts which require reparation. Expenditures for the cleaning of works of art has been estimated and included in other expenses of the estimations. The proposed solution for art works is shown in Table 3 of Annex 1. The volumes of works for repairing the culvert are shown in Table 7, Annex 3 and forests in Table 8, Annex 3.

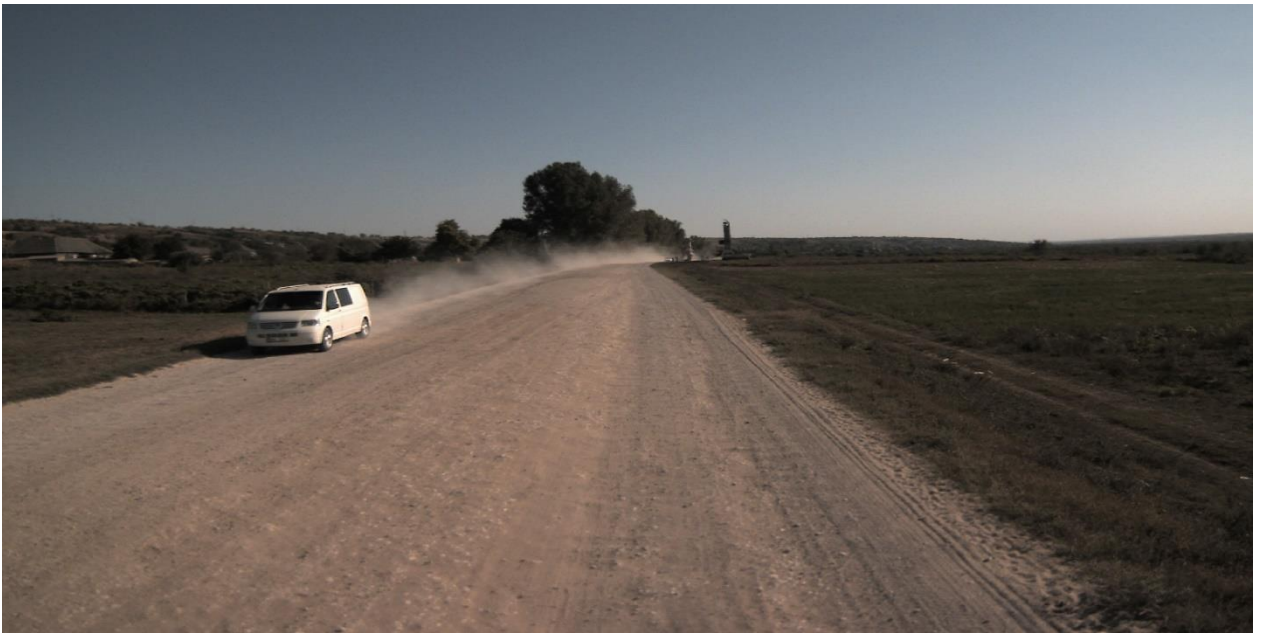
Crossing the gravel road structure into a cement concrete road structure will significantly reduce the dust concentration in the 50 - 100 m area of the road. In particular, this will be accentuated in the localities, where the dust clouds were located in the households of the inhabitants.

Figure 5.1.1.1 Dust clouds formation on the gravel roads

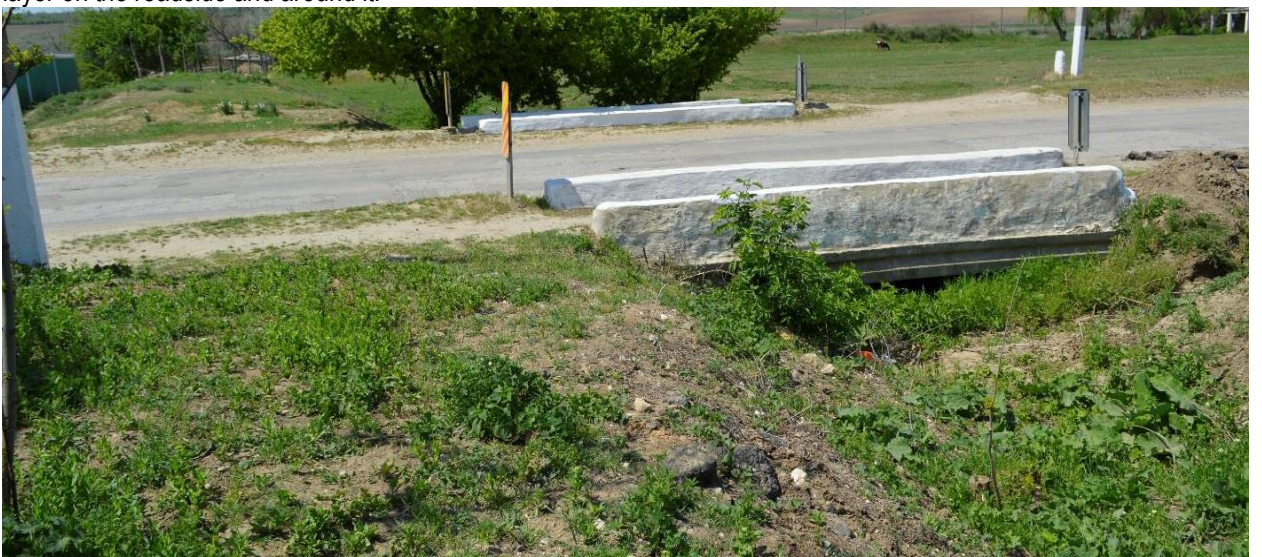
Due to defects in capture and evacuation systems of rainwater, there are cases of soil erosion with the tendency of forming the ravines, which in the future can lead to the destruction of the road embankment. In the place where are culverts with sludge, there is evidence of the flooding of the adjacent land with the subsequent formation of a sludge layer on the roadside and around it.

Figure 5.1.2.1. Silted culvert on km 6, 80
