# Modernization of local public services in Republic of Moldova

## THE SECTORAL REGIONAL PROGRAM IN THE FIELD OF LOCAL AND REGIONAL ROAD INFRASTRUCTURE FOR UTA GĂGĂUZIA DEVELOPMENT REGION

### CORRIDOR # 2

## R29–Ferapontievca– Avdarma – Chiriet Lunga– R36

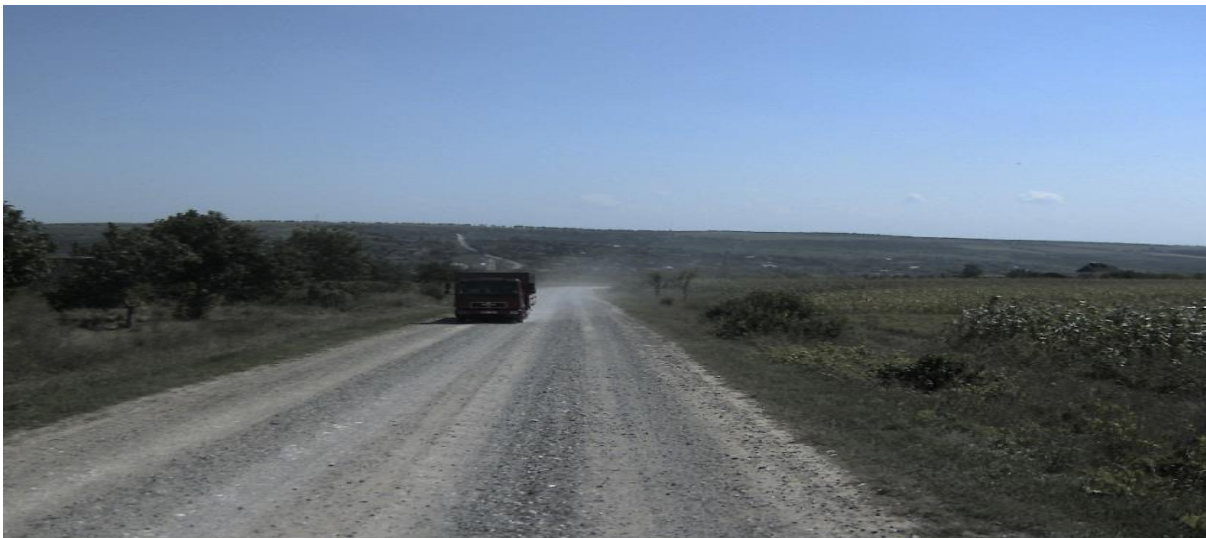
The technical condition of the road essentially influences the environment. Road unevenness (pits, subsidence, etc.) stimulate noise and vibration increase as well as fuel consumption (up to 20%), which increases the amount of harmful emissions in the atmosphere. Roads with gravel coverage are sources of dust, which negatively affect the area around the road (50-100 m). In particular, this is evidenced during the summer, when the plantations are covered with dust, which essentially diminishes the photosynthesis process, thus reducing the harvest of the agricultural crops. It also negatively affects the localities, where dust clouds settle in the households of the inhabitants.

Figure 3.9.1. Dust clouds formation on the gravel roads

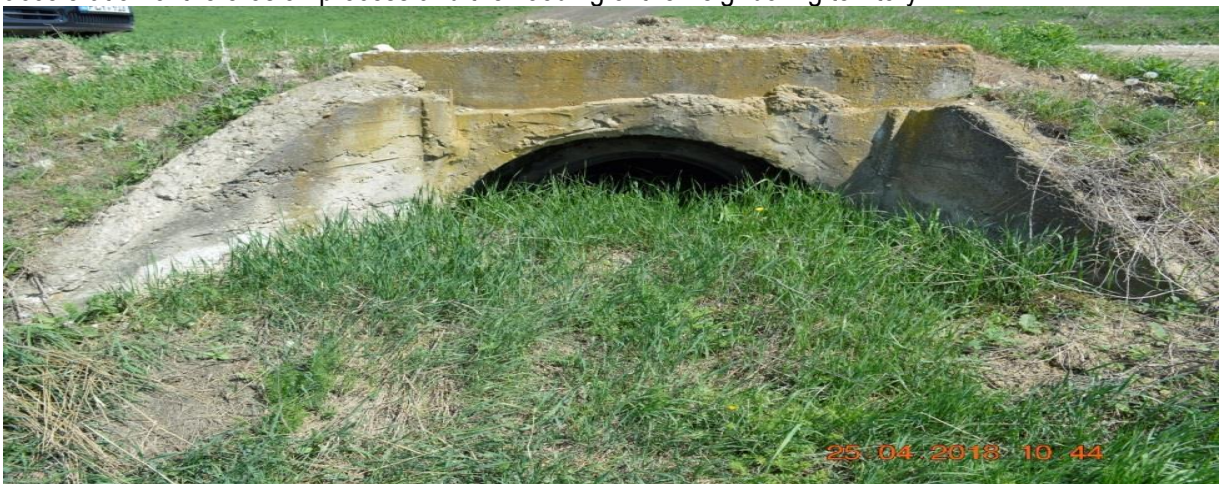
The unsatisfactory level of maintenance of art works has contributed to the erosion of downstream alluviums to some culverts, as well as the mudslide of an essential part of the culverts. This has contributed to the acceleration of the erosion process and the flooding of the neighboring territory.

Figure 3.9.2. Silting an essential part of the culvert

There are 4 bridges on the route, 3 of which require mud and shrub cleaning, as well as local repair works. The bridge at km 0.590 was rebuilt in 2016 and is in good condition. 7 of 9 culverts require cleaning and repair of portals and wings. Expenditures for the cleaning of works of art has been estimated and included in other expenses of the estimations. The proposed solution for art works is shown in Table 7 of Annex 3. The volumes of works for repairing the culverts are shown in Table 8, Annex 3.

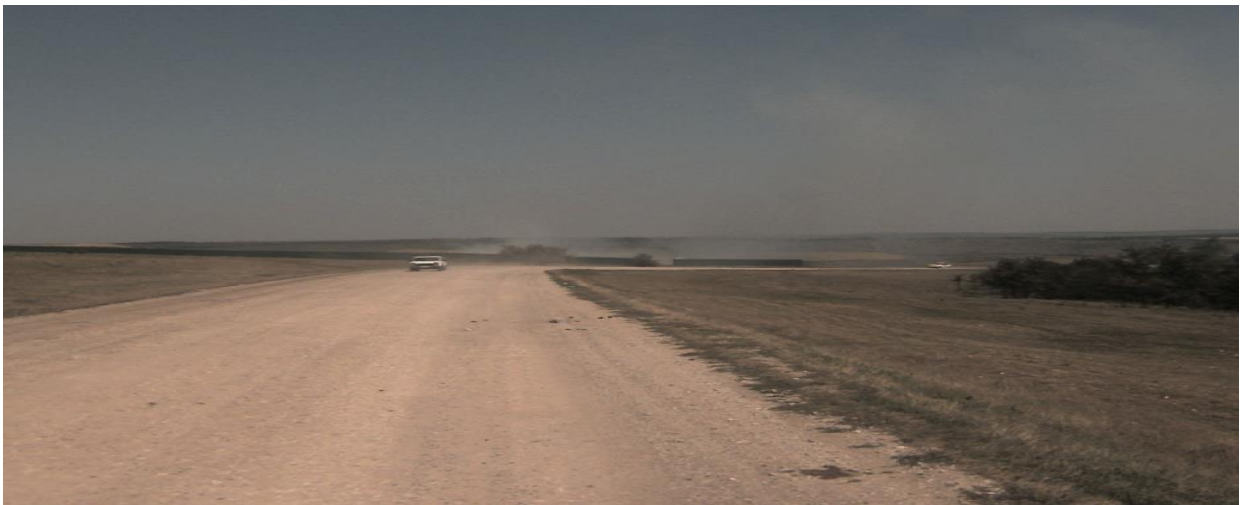
Changing gravel coverage into cement concrete coverage will significantly reduce dust concentration in the 50-100m area of the road. In particular, this will be emphasized in localities, where dust clouds were sitting in the households of the inhabitants.

Figure 5.1.1.1 Dust clouds formation on the gravel roads.

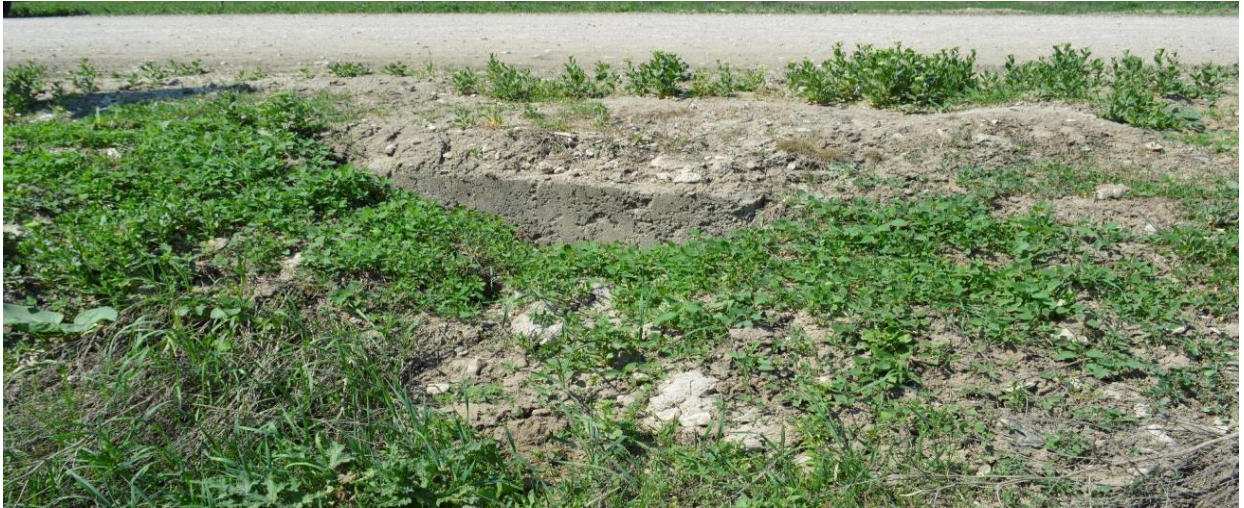
Due to defects in capture and evacuation systems of rainwater, there are cases of soil erosion with the tendency of forming the ravines, which in the future can lead to the destruction of the road embankment. In the place where are culverts with sludge, there is evidence of the flooding of the adjacent land with the subsequent formation of a sludge layer on the roadside and around it.

Figure 5.1.2. silted culvert on km 14,800
