Modernization of the Local Public Services in the Republic of Moldova

Project Concept (report on walk-through energy audit)

Sport Complex of the Comrat State University, Comrat municipality

May 2018

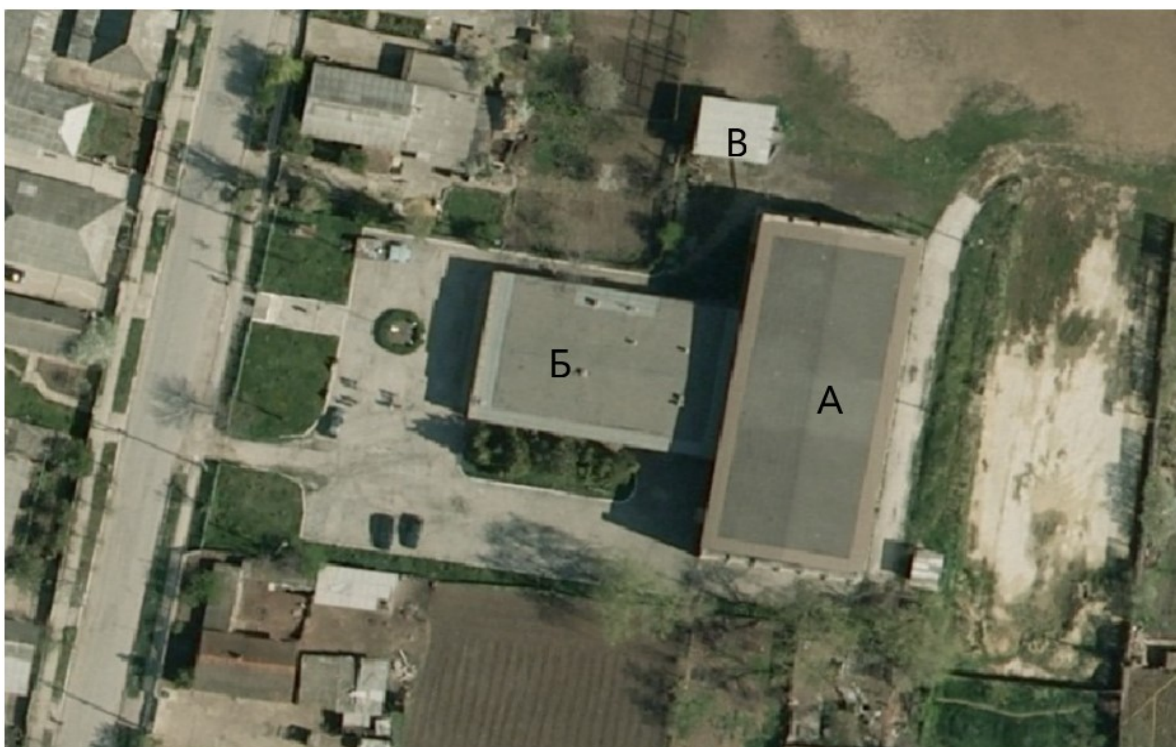
Photo 2 Sport Complex (Orto photo), Scale 1:500 . Source – www.geoportal.md.

Components (mentioned on the photo 2):

- A – main block of the Sport Complex (gym)
- Б – auxiliary block (locker rooms, showers, storage rooms, classrooms etc.)
- B – boiler house.

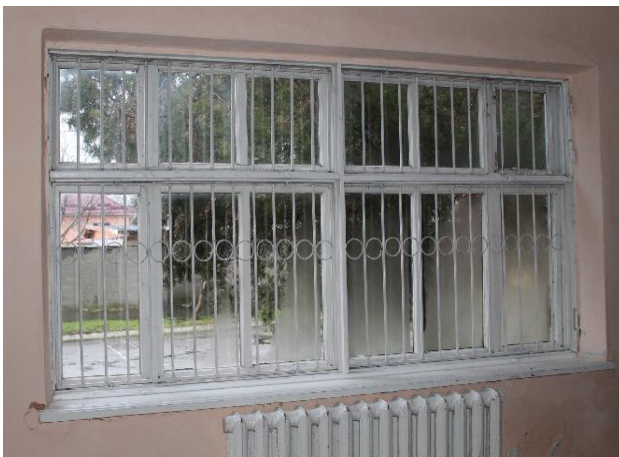
Photo 3 Wooden window, south façade

In the whole building wooden and metal doors and windows are installed, some are badly closed or have cracks along the perimeter, letting the outside air inside. The windows in the gym are in very poor condition, as they are exposed to moisture (rainwater is flowing directly from the damaged roof).

Replace obsolete windows and doors with PVC double glazed windows, in the northern part of the building energy-efficient glass Low-E could be used. Ensure embedding of slopes using insulating membranes. External (tin) and internal sills (plastic) should be replaced, also. The windows in the gym should be provided with the possibility of automatic remote opening in case of need for additional ventilation.

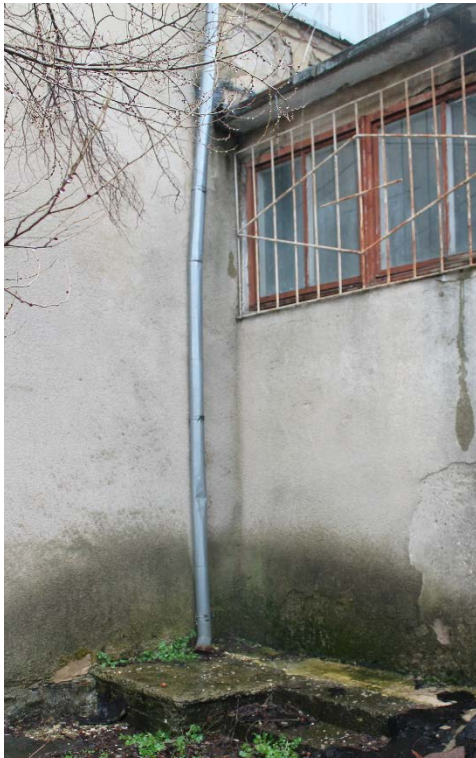
Photo 5 Rainwater drain, connection between block A and B

The roof of the whole building is flat with soft type of coating material. Under the roof there is no attic or technical floor. In Block B, there are no roof leaking signs, in contrast to Block A, where this process is very easy to see. Water from block A is evacuated through a single drain or the precipitation is drained off the edge of the roof. Total roof area is 1400 m².

It is also necessary to ensure the evacuation of rainwater through drains. For the pipes that goes down, it is important to remove the end away from the building walls (according to the requirements) in order to prevent the destruction of the blind area along the entire perimeter of the building.

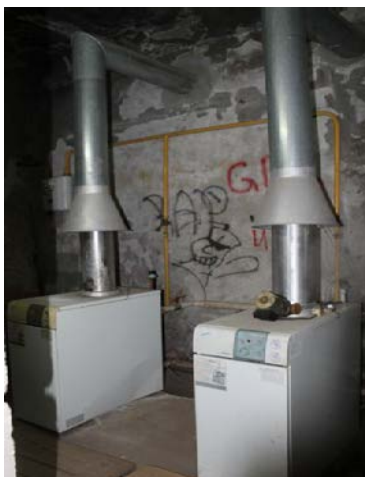
Photo 7 Boiler house

The building is heated by its own gas boiler house. In a stand-alone building (Block B) 2 boilers are installed. From the boiler house, the thermal agent is going through insulated pipes (about 10 m), passing above the ground, enters the building, where it is distributed throughout the system. At the time of the visit there were no events in the building, the temperature in the building was kept at a minimum level. The heating system is two-pipe, in the block A tubular radiators covered with wooden grilles are installed, in block B - mainly cast-iron radiators are installed.

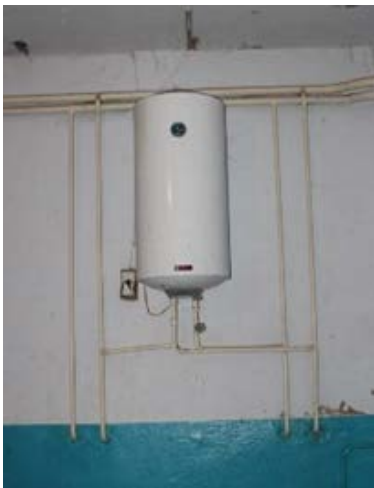
Photo 8 Electric boiler

One boiler with the capacity of 100 liters is used for the preparation of hot water, which is supplied to the shower rooms. Type of boiler - Thermex, power - 2 kW. For reasons of economy, the boiler is only used on demand. The possibility of preparing and supplying hot water from the boiler house is not provided.

The preparation and supply of hot water from the boiler room should be provided or solar panels on the roof of the building should be considered as a solution to provide shower rooms with hot water. Since hot water is required during peak hours in a larger amount, the hot water supply system should be considered with a storage tank to ensure maximum draw-off. To properly calculate the right amount of solar panels and the necessary load, to invite a specialist in heating technology.

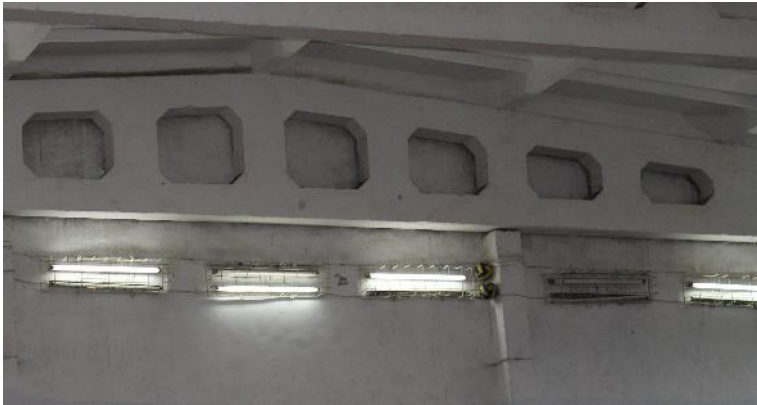
Photo 9 Lighting in the gym

In the block A, fluorescent lamps are used around the perimeter of the room for lighting. The illumination level is quite low, individual segments do not work.

In all the building the lighting devices should be replaced. LED lamps are suggested to be used, in the gym it is necessary to provide partial lighting of the room (for training with the participation of a small number of people). Considering the fact that during the visit the impression of poor lighting in the gym was created, it was necessary to recalculate the necessary number of lighting devices and their location. In the corridors, use motion sensors to automatically turn off the lighting in the absence of movement.
