## Modernization of the Local Public Services in the Republic of Moldova

### Project Concept (report on walk-through energy audit)

House of culture, Congaz village, Comrat rayon

May 2018

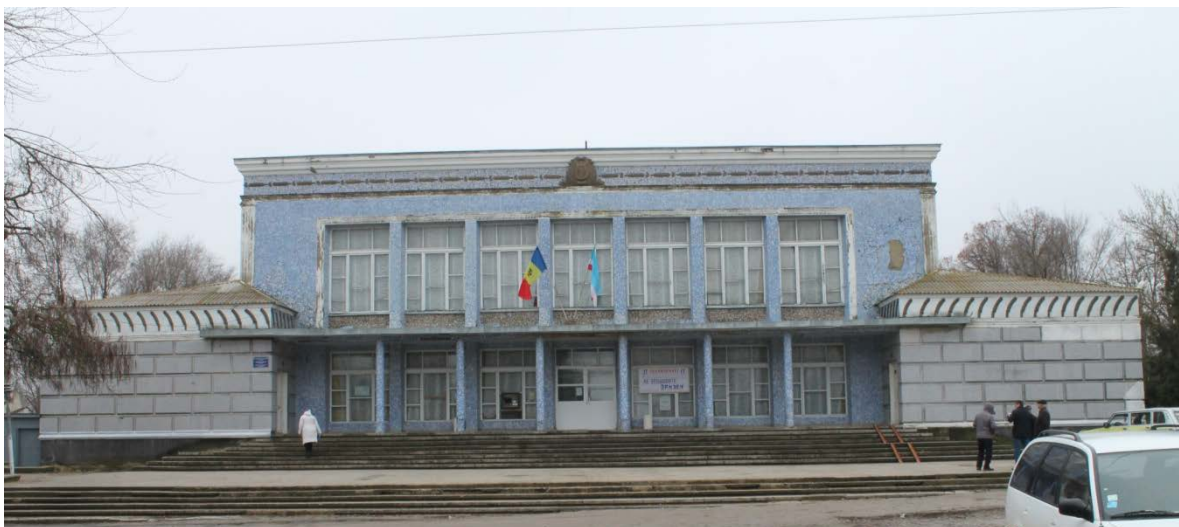
*Photo 1 House of culture in Congaz village, main facade*

The building was built in 1972. On the ground floor, the main concert hall is located. Also, there is a small hall closed by that used to be a restaurant, but at the moment it is used for small events. Here could be found several auxiliary rooms and training halls. On the second floor there is a hall for marriages, as well as several rooms that are used by the local registry office for state registration of acts of civil status. The working staff of the cultural center consists of 24 employees.

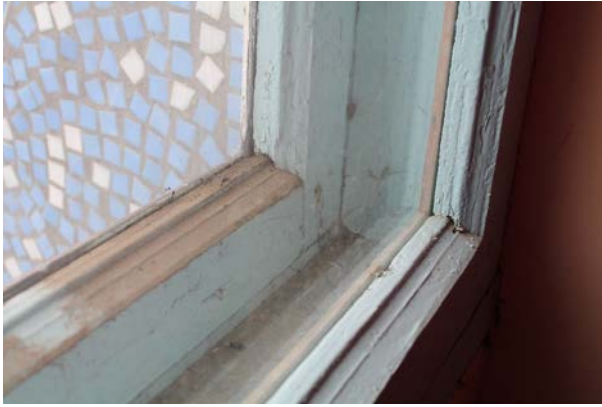
Almost all the windows and doors are old-type: double wooden frame separated with a small distance and with one layer of glass on each frame. Few windows were replaced with PVC constructions due to poor technical condition (on the side part of the building). Main entrance and vestibule doors were replaced also.

*Photo 4 Double wooden framed window with one layer of glass*

**Replace windows and doors with PVC constructions with double-glazed windows**, keeping the dimensions of the openings. In the northern part of the building energy-efficient glass Low-E could be installed. Ensure embedding of slopes using insulating membranes. External (tin) and internal sills (plastic) should be installed.

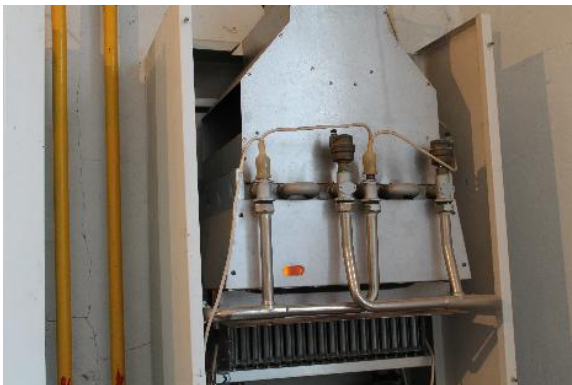
The building is heated by 2 boiler houses. One of the boiler houses is located inside the building in the north-western part, the second boiler-house is an annex to the building in the south-western part. The internal boiler room is equipped with two boilers and provides heating to the second floor of the building. The external boiler room provides the thermal agent to the rest of the building. Both boiler houses operate on natural gas. Internal heating networks in the lobby are replaced, the radiators are replaced by aluminum ones. Other networks and radiators are old model (cast iron).

*Photo 5 Gas boiler in the interior boiler house*

It is necessary **to replace the equipment in the boiler houses and internal heating systems**, with the installation of individual heat regulators. The current organization of the heating system does not allow the regulation of the heat supply for only one part of the building, therefore, the experts' recommendation is to install additional equipment to regulate the supply for different parts of the building, allowing to heat or disconnect unclaimed rooms or areas of the building.

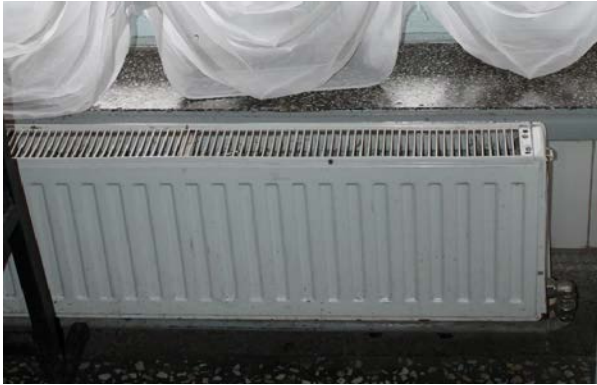
*Photo 6 Radiator in the vestibule*

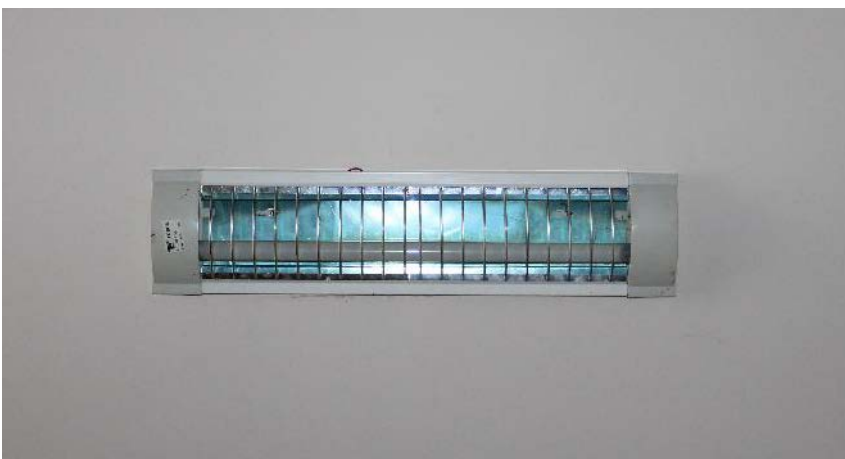
Fluorescent and incandescent lamps are used in corridors and various rooms for lighting. Energy saving lamps (35 pieces) are used in the concert hall and on stage. There are 605 units of lighting in the entire building with the average power of 75 watts.

*Photo 7 Lighting in the vestibule*

**Replace the existing lighting with LED lamps**. In the concert hall where special lighting is necessary, general lighting and special illumination for the stage should be provided. In the corridors, **motion sensors for automatically turn off the lighting** in the absence of moving should be installed.

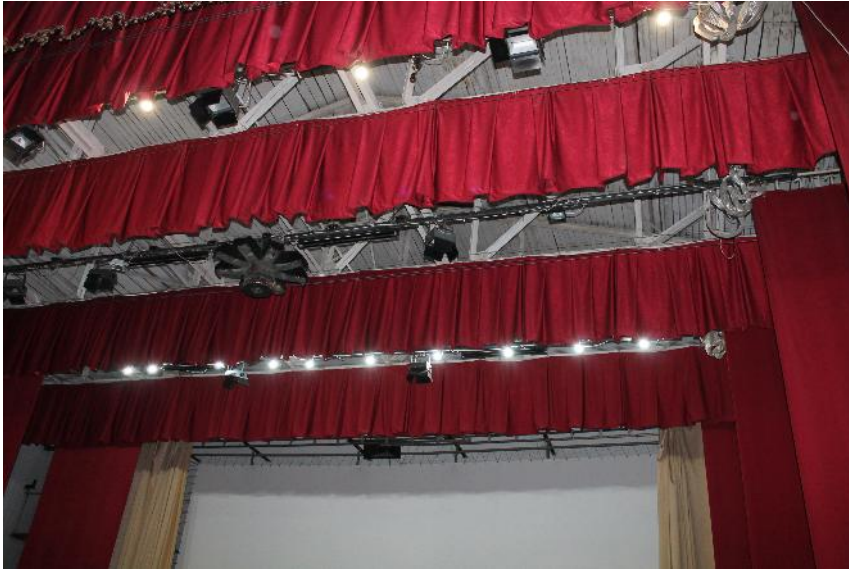
*Photo 8 Lighting on scene*
