Modernization of the Local Public Services in the Republic of Moldova

Project Concept (report on walk-through energy audit)

Professional school, Ceadir – Lunga municipality

May 2018

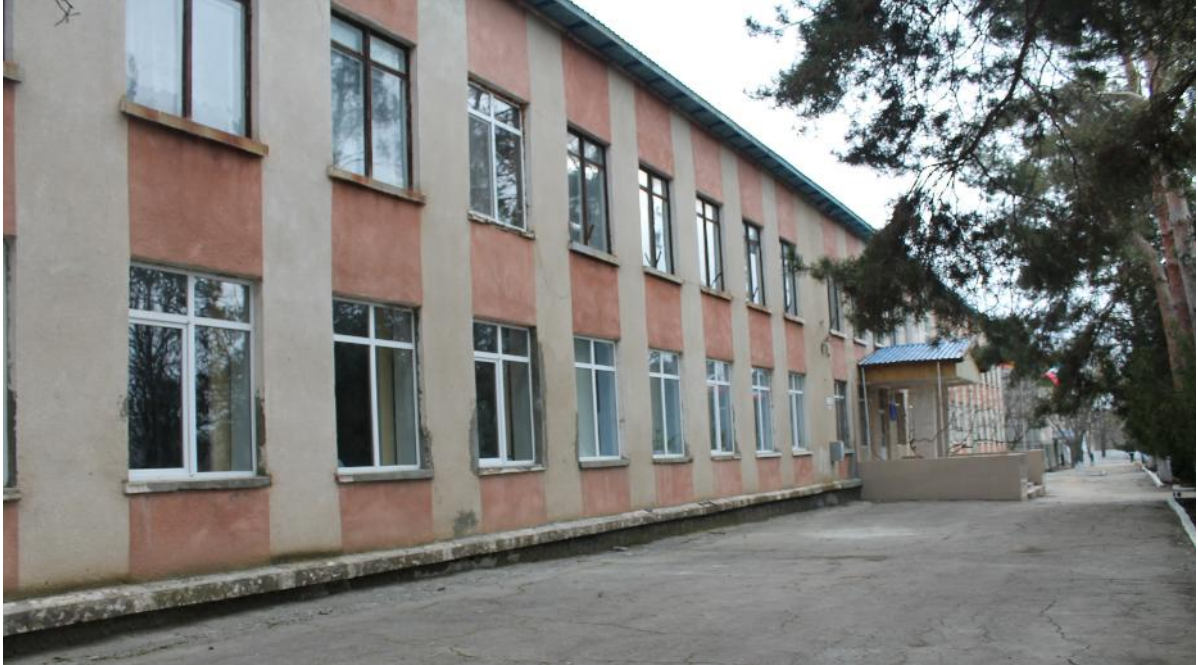
Photo 1 Professional school in Ceadir-Lunga municipality, western facade

Main building was built in 1965.

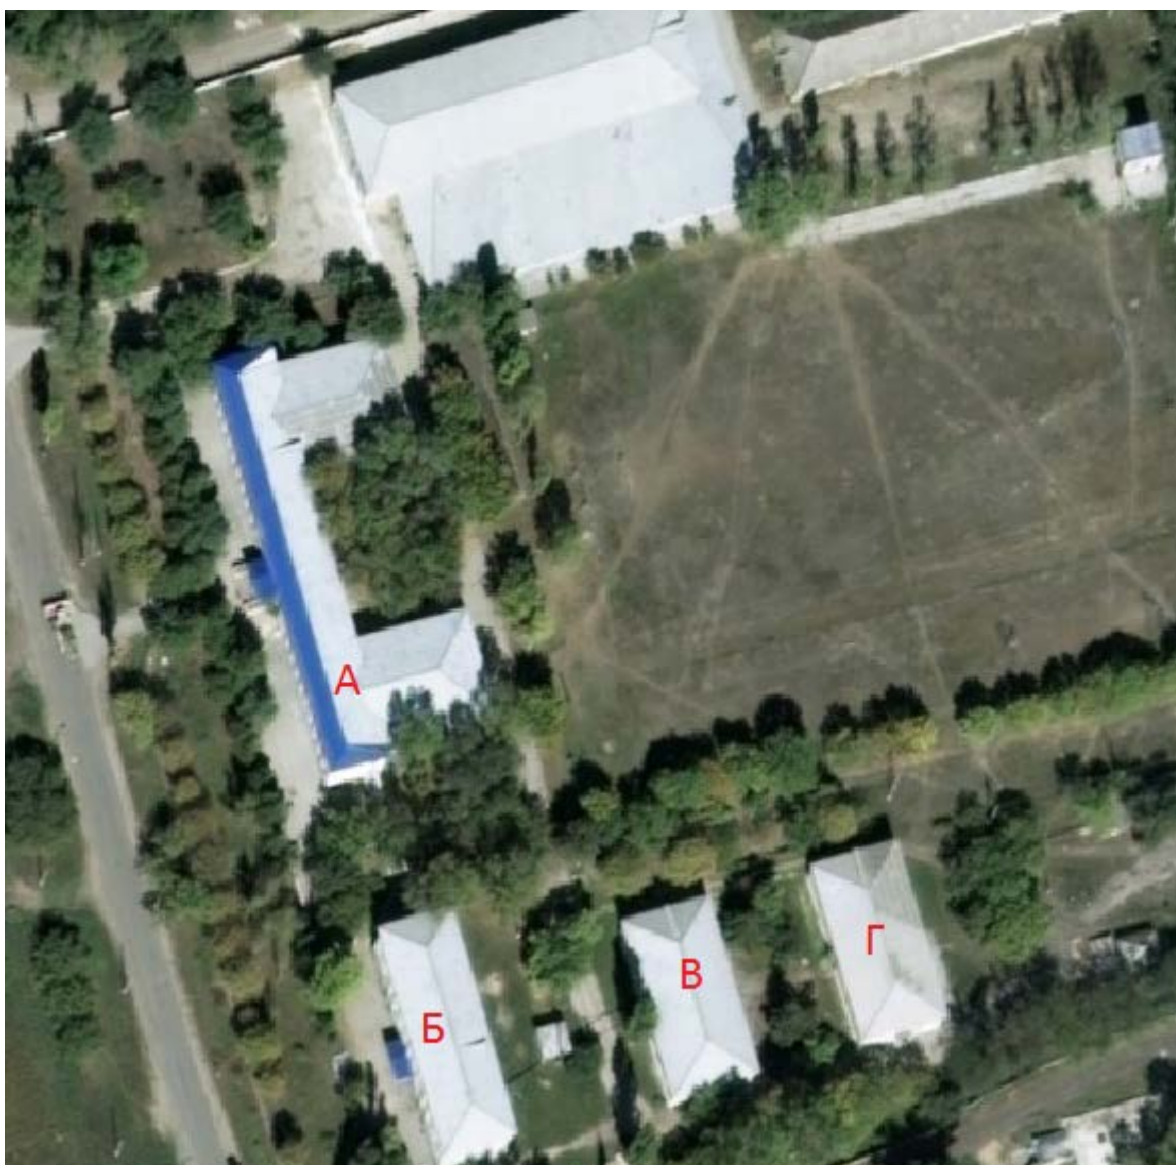
Photo 2 Professional school, Orto photo, S 1:1000. Source – www.geoportal.md

The components (indicated in photo 2):

В – Laboratories;

Г – Dormitories (unused)

Note: in this concept only the main educational building of the complex is considered.

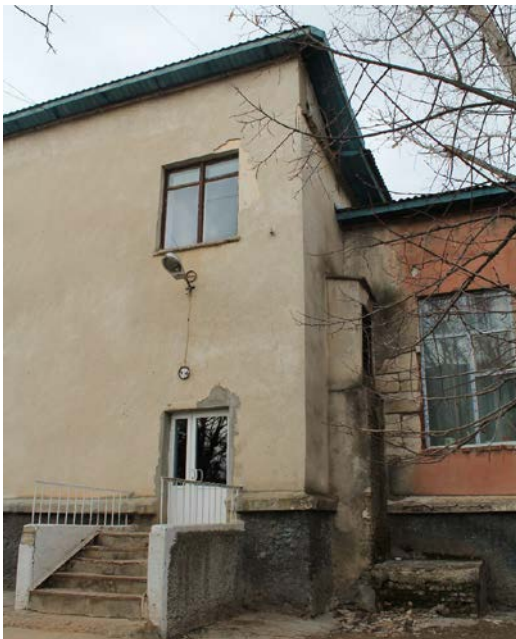
During the last several years 30% of the windows were replaced with double glazed PVC windows. The profile is thick; in some places the seals are not properly finished. Other 70% of the windows and doors are old, and in a very poor condition.

PVC	Wooden
Windows	34	60
Surface of the windows	120 m ²	210 m ²
External doors	2	2
Surface of the doors	6 m ²	3 m ²

Photo 3 Windows and external door, north facade.

Replace obsolete windows and doors on PVC structures, taking care of the dimensions of the door and windows openings. Ensure embedding of slopes using insulating membranes. Install external (tin) and internal window sills (plastic).

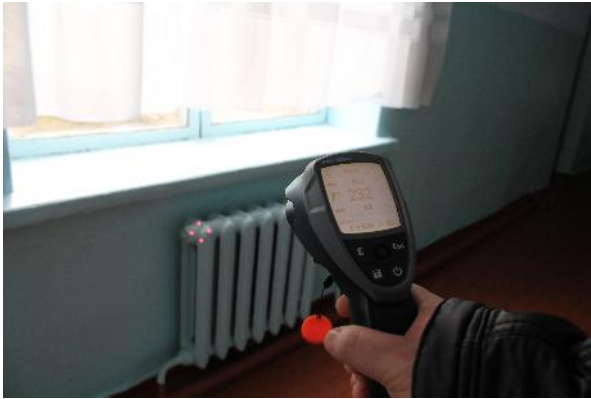
The building is heated by its own gas boiler house. Access to the boiler room is limited, as it is carried out by a separate economic agent. Heating system is two-pipe, radiators are old type made mainly from cast-iron. In large rooms, the radiators are tubular, covered with protective screens.

Quantity of radiators – 94 units.

Photo 4 Radiator in the corridor of the first floor and measuring of its temperature.

The replacement of old radiators is recommended. New radiators should be equipped with thermostatic regulators. In the gym, to provide such protective screens for radiators, which will not create any minimization in the heat distribution.

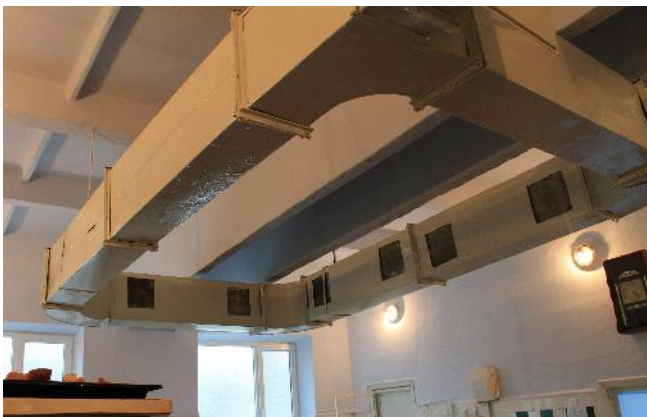
The centralized ventilation system in the building is present only in the kitchen. The ventilation holes in gym are covered. Ventilation holes for natural ventilation in the walls are present, having a direct connection to the roof.

Photo 5 Ventilation system in the kitchen

Ventilation should maintain an optimum temperature and supply of fresh oxygen into the rooms. The intensity of air exchange should be calculated on the basis of current standards. To ensure comfort in the gym and canteen room, it is recommended to restore the vent in the ceilings (natural ventilation system), equip them with a heater and pallets to drain the accumulated condensate. For classrooms, it is proposed to use supply and exhaust ventilation devices in case if it is not impossible to clean and restore channels for natural ventilation.

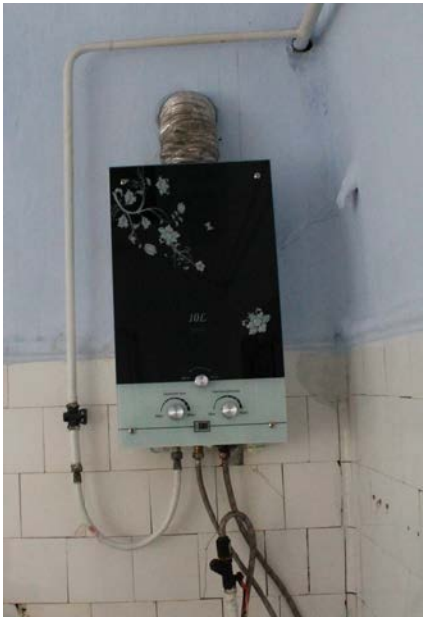
For preparation of the hot water a gas water heater is used, its capacity is 10 liters, the hot water is supplied just at the kitchen. There is no possibility to prepare and provide the hot water from the boiler house.

Photo 6 Gas water heater, in the kitchen.

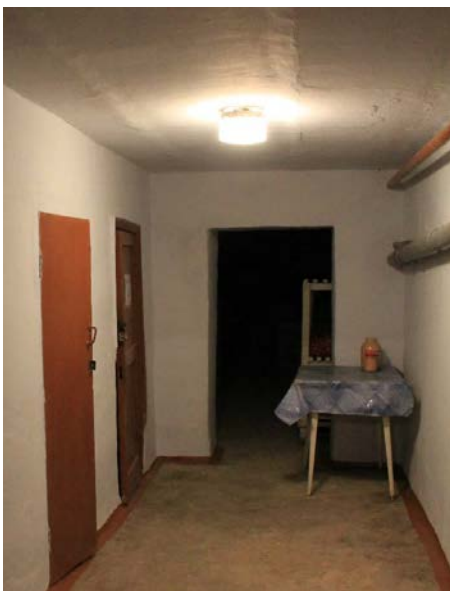
For lighting, fluorescent and incandescent lamps are used.

Incandescent lamps	Fluorescent lamps
Quantity	68	120
Power	100 W	100 W

Photo 7 Lighting in the basement.

Throughout the building, replace the lighting devices with LED elements. In the corridors it is recommended to use motion sensors which will automatically turn off lights when there is no movement.
