Modernization of the Local Public Services in the Republic of Moldova

Project Concept (report on walk-through energy audit)

Professional school, Vulcanesti

May 2018

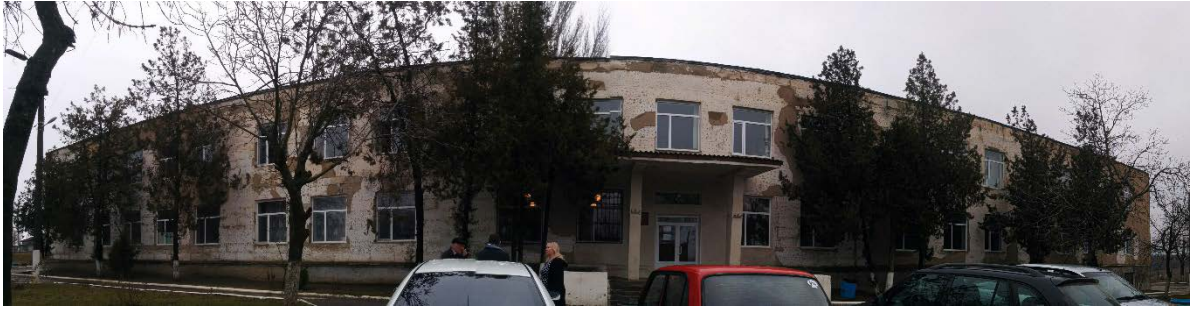
Photo 1 South façade of the main study block (panoramic view)

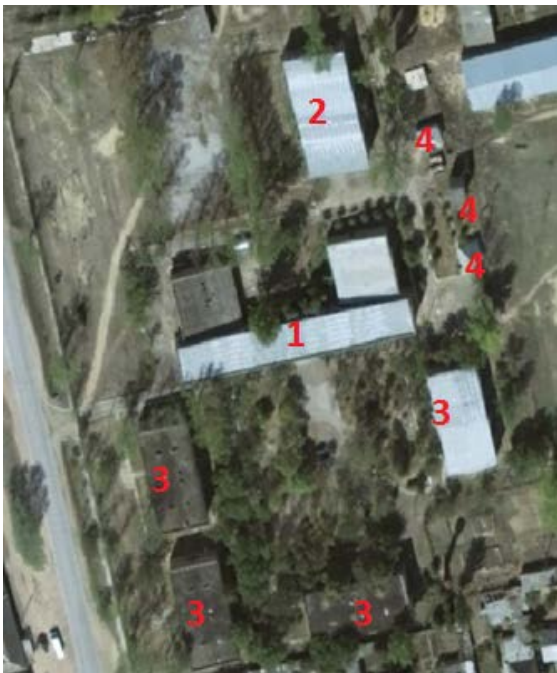
On the territory of the school following buildings are located (photo 2):

1. Main study block
2. Laboratory
3. Dormitories
4. Auxiliary buildings (boiler house and storage)

Photo 2 Spatial arrangement of the various blocks of the school (Ortho photo, Scale 1:1000)

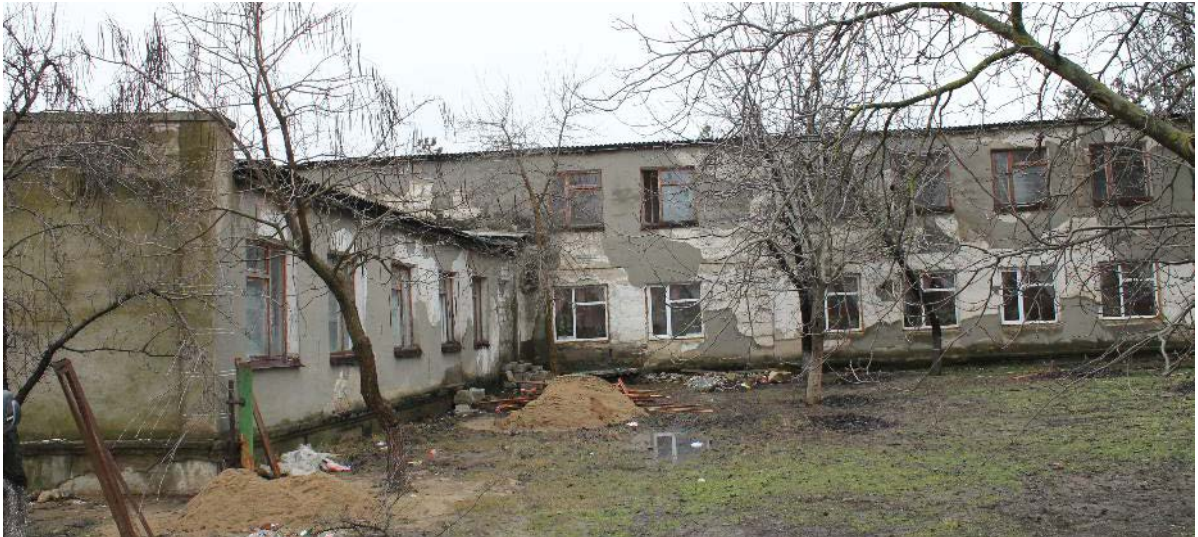
Photo 3 Part of the south façade (central 2 levels part and left wing of the building)

The building is built of large limestone blocks, the width of the bearing walls is 500 mm, the thickness of the basement walls is 700 mm. The floors are separated by reinforced concrete slabs. In bearing structures, no damage was observed. The masonry of the walls is exposed on the biggest part of the facades, the plinth is also damaged, there is no blind area along the entire perimeter of the building. It was noticed that the floors of the first level are skewed (especially noticeable in the corridor on the way to the gym). Probably, the walls of the basement room under it sag because of the constant humidity, but the final verdict about the safeness of exploitation of this part of the building should be announced by technical expertise.

- Thermal insulation of building facades with a layer of rock wool is recommended (total area of the external walls is 1800,26m²). Before installing the thermal insulation material, remove the existing coating.

It is recommended to insulate the ceiling of the basement with XPS or rock wool (633 m²).

The plinth must also be insulated with a thinner layer of XPS to prevent the penetration of cold directly into the room and its base, as well as to create a barrier to ground moisture and water generated by melting snow. Its installation will require exposing the foundation walls to 50 cm from the ground level, that is, the total height will be 1 m. The walls of the basements should be completely insulated with the same layer of XPS. After installation, the blind on the entire perimeter should be created, keeping a slope of at least 7 degrees from the walls of the building. A blind with a width of 70cm must be framed with a curb, which allows drainage of rainwater.

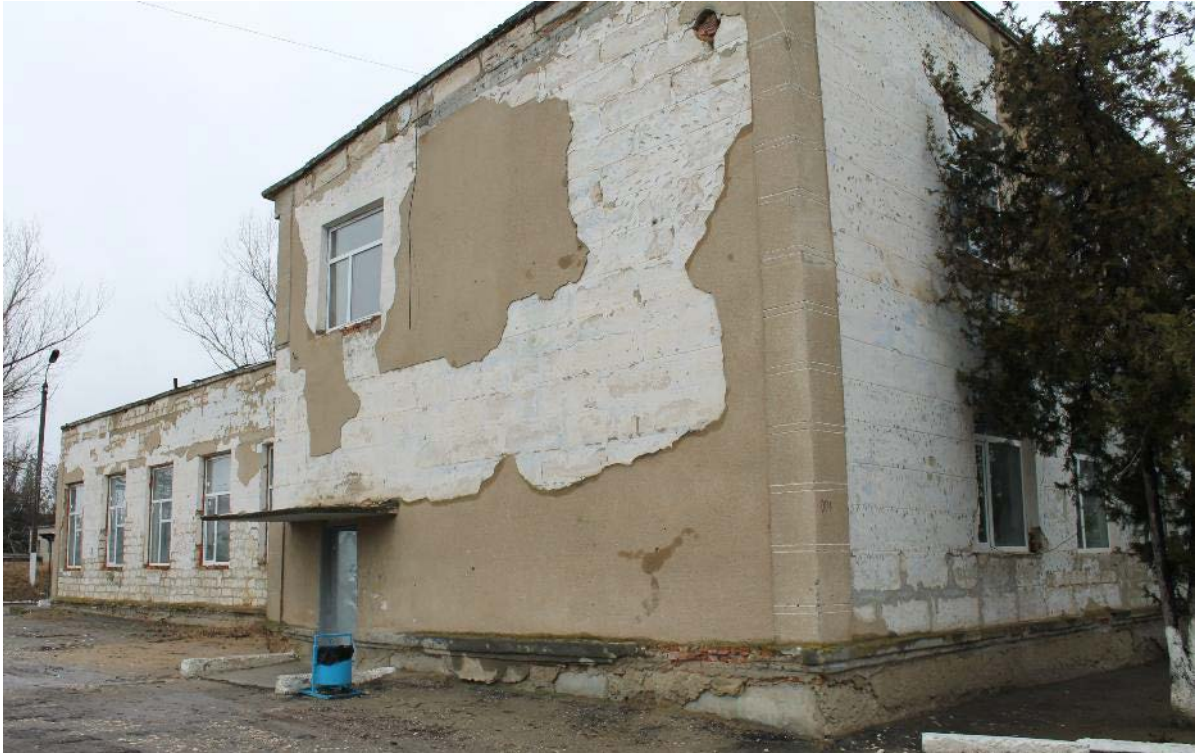
Photo 4 West façade of the building

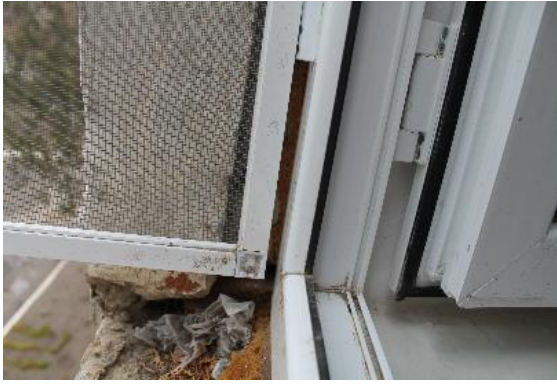
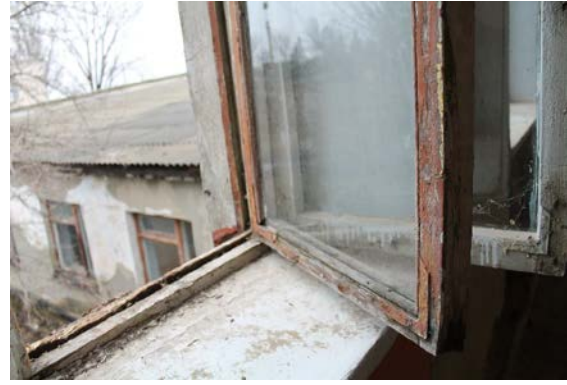
A part of the old wooden windows and the doors of the main entrance were replaced with PVC double glazed windows and doors. The slopes of the replaced windows are not finished. The windows of the back side of the building (north part) are wooden double framed with one layer of glass each frame.

Photo 5 New and old windows on the second floor

- Replace obsolete windows and doors with PVC double glazed windows, in the northern part of the building energy-efficient glass Low-E could be used. Ensure embedding of slopes using insulating membranes. External (tin) and internal sills (plastic) should be replaced, also.

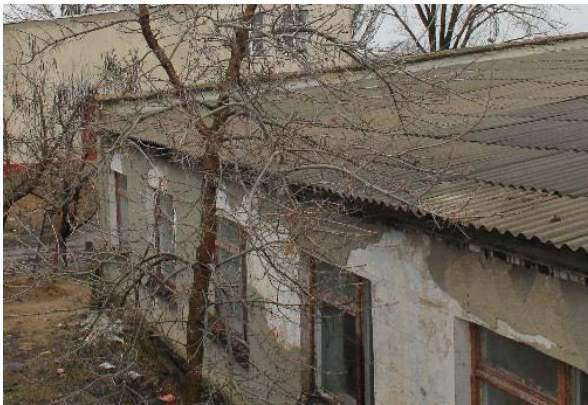
The roof is sloped and the coating layer is asbestos-cement sheets. The roof is damaged and leaking in some places. There is no rainwater management system supposed. Total area of the roof – 1478 m².

Photo 6 Roof over the gym

- Experts propose the **thermal insulation of the ceiling of the last floor and installation of a new sloped roof**. It is recommended to install a thermal insulation layer of mineral wool, with the laying of vapor barrier and waterproofing membranes.

It is also necessary to ensure the evacuation of rainwater through drains. The walls and the blind area should be protected from destruction through properly installed drain pipes.

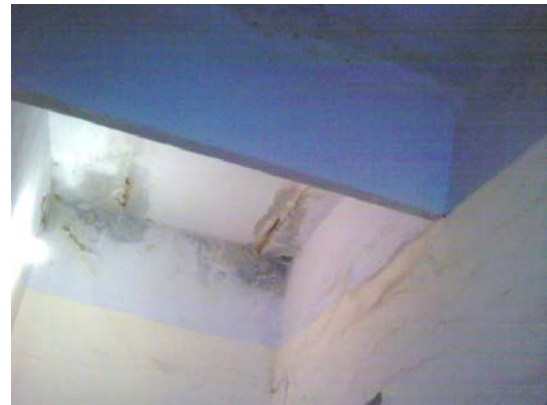
Photo 7 Signs of roof leaking in the corridor

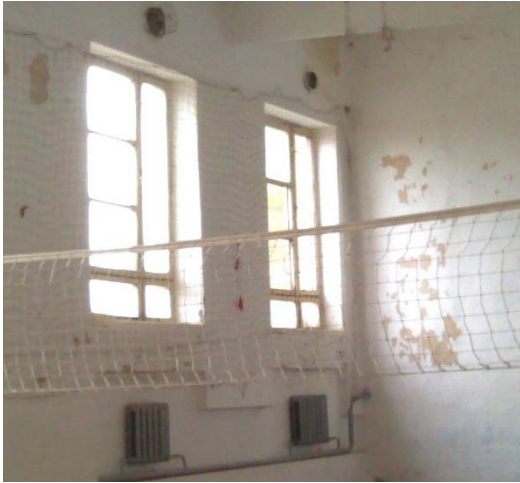
The main block of the school is heated by the boiler house with 3 boilers installed inside (2 of them are working and one is reserve). The thermal agent is pumped into the external insulated pipes that are positioned underground. Internal heating system consist of cast-iron pipes and radiators.

Photo 8 Radiators in the gym

During the visit, it was found that in the gym and canteen, despite the working heating system, the temperature in the rooms is low. Experts propose to recalculate the size of the radiators for these spaces in order to increase them, for more comfortable conditions. It should also be possible to regulate the supply of thermal agent to the gym and canteen in order to save energy.

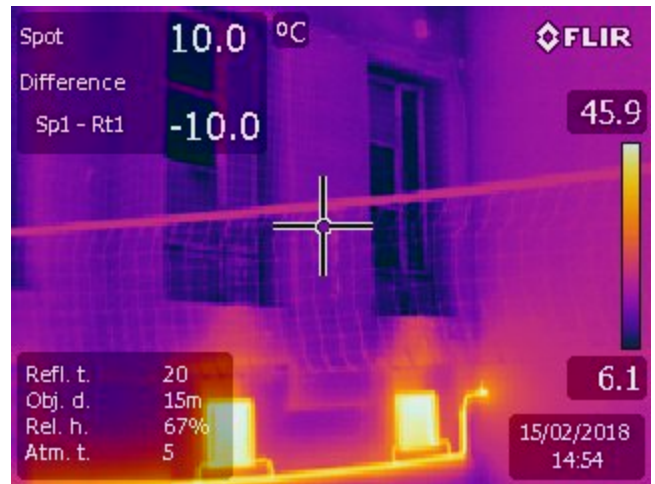
Photo 9 Radiators in the gym (view from infrared camera)

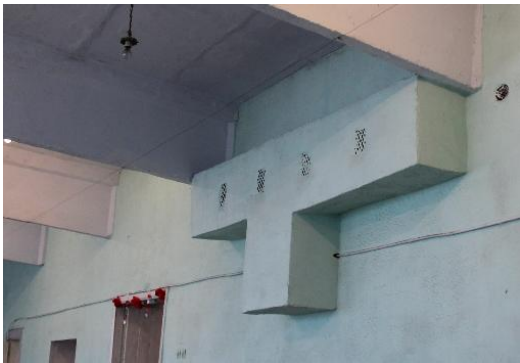
Vent holes in the walls designed for natural ventilation have direct access to the roof of the building. In the classes where the windows have been replaced, traces of mold could be observed.

Photo 10 Vent holes in canteen

Natural ventilation in the rooms is not efficient, therefore additional ventilation equipment should be installed - it is proposed to install air-handling units with a heat exchanger for classrooms.

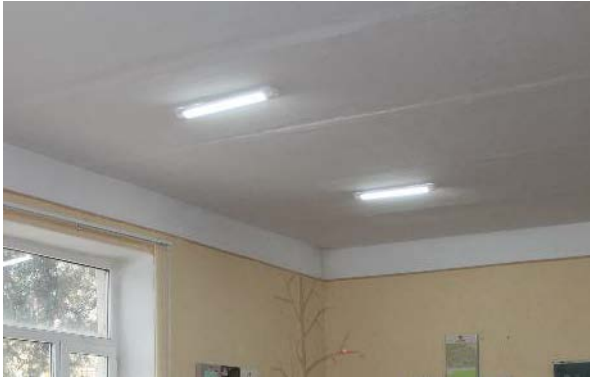
For illumination, LED lamps with the 20W power are used (152 pieces in the entire building).

Photo 11 Lighting devices in classroom, first floor
