Modernization of the Local Public Services in the Republic of Moldova

Project Concept
(report on walk-through energy audit)

**Regional Sports Boarding School,
Comrat municipality**

Project Concept (report on the walk-through energy audit)

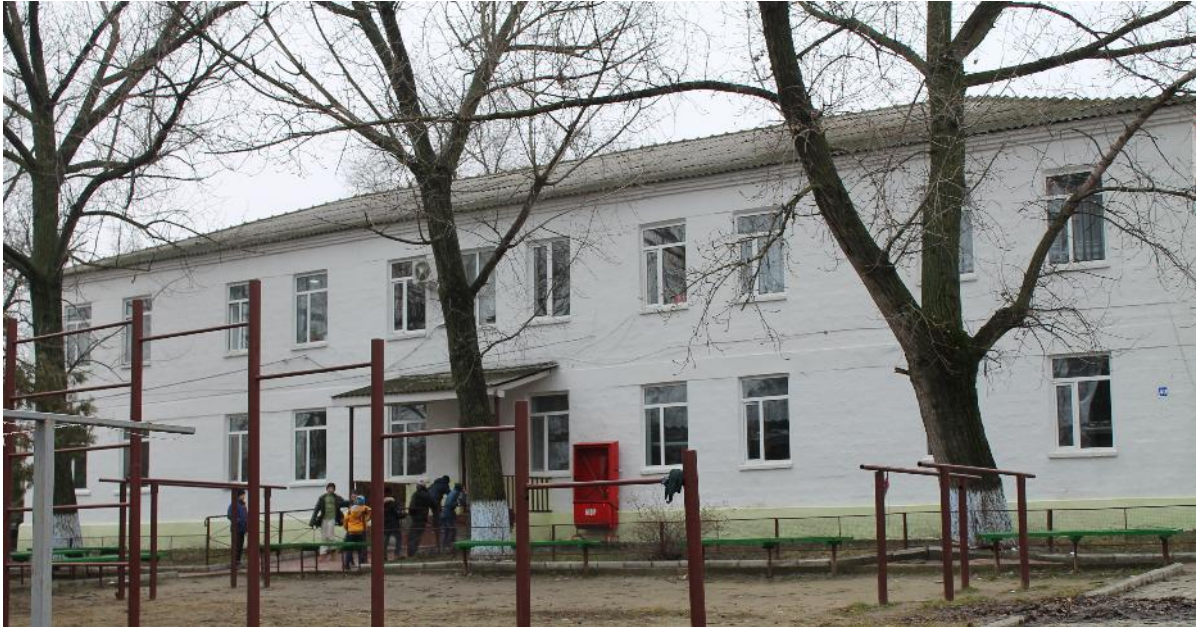
Photo 1 Regional Sports Boarding School in Comrat, East facade

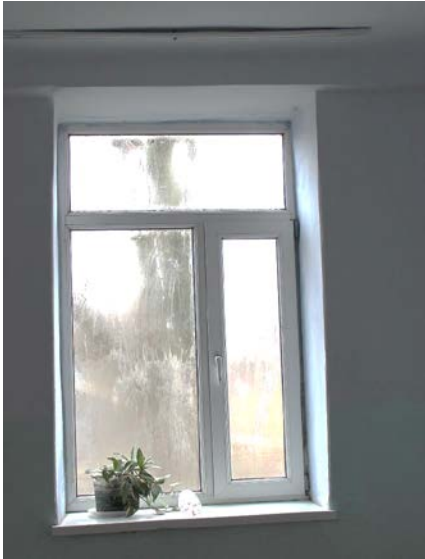
During last several years, all the windows and external doors in the building were replaced with double glazed PVC constructions.

Photo 3 Window on the first floor.

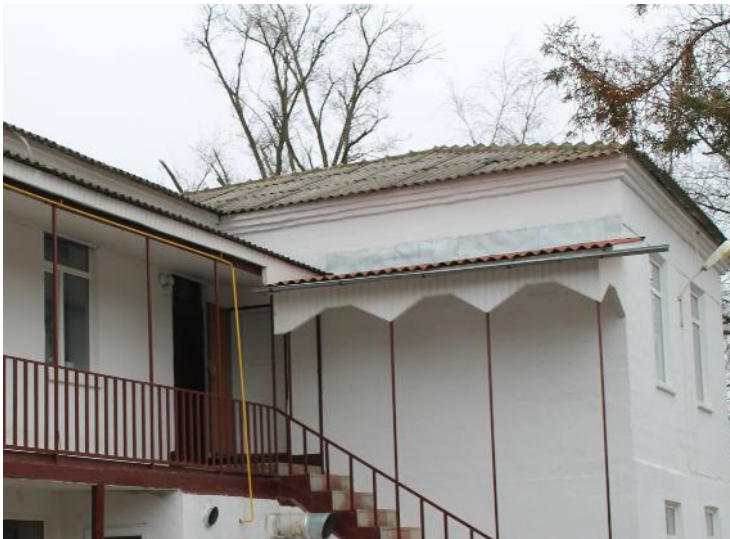
The pitched roof is covered with asbestos sheets. The attic is not affected by the leaks.

Photo 4 Pitched roof, north part of the building

Due to the considerable service life of the old roof, the experts propose a complete removal of the existing roof coverage. Also, the replacement of rafter system should be considered. For the subsequent operation it is proposed to install a new pitched roof, with appropriate hydro and thermal insulation, as well as the insulation of the attic floor with thermal insulation materials (such as rock wool or similar).

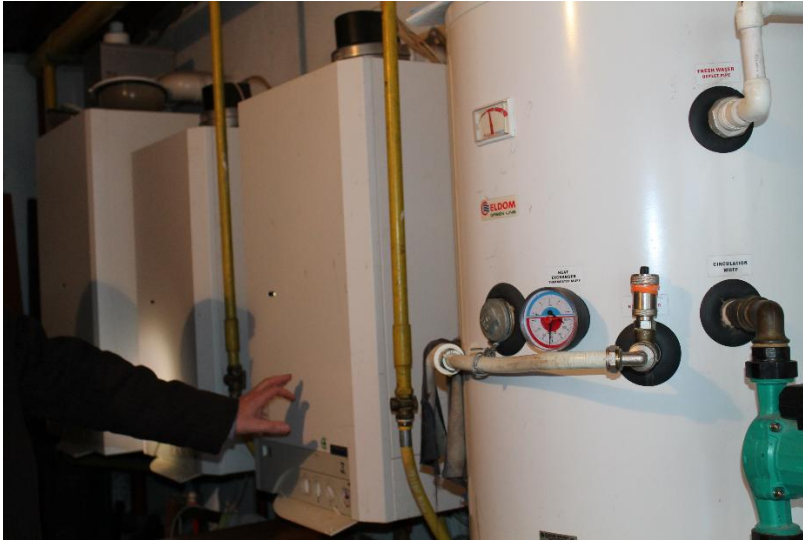
The building is heated by the boiler house powered by natural gas. In the separate building (block B) 3 gas boilers are installed and one separate boiler for hot water preparation. The heating agent is transported on the shortest way through insulated pipes directly into the heating network inside the building, no separate thermal point is installed. Two-pipe system is providing heat through cast-iron heaters.

Photo 5 Gas boilers in the boiler house

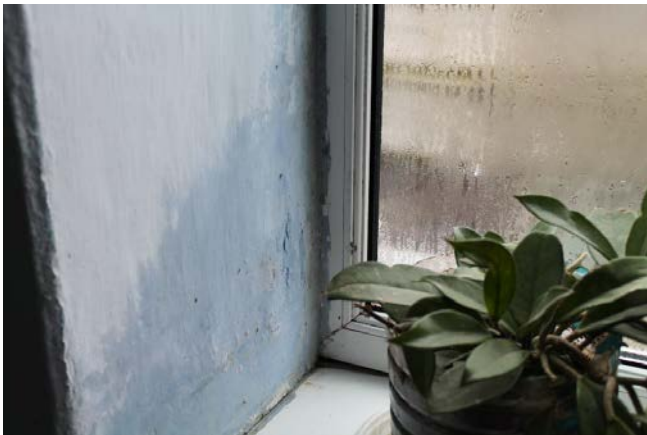
There is no central ventilation system installed in the building. The natural ventilation is ensured by regular opening of the windows. There is a high level of humidity in the building.

Photo 6 Consequences of the low ventilation level, first floor, classroom

It should be kept in mind that ventilation should maintain the optimum temperature and the flow of fresh oxygen to different rooms, and there should not be strong airflows in the rooms. The intensity of air exchange should be calculated on the basis of current

standards. For classrooms, it is proposed to clean and restore channels for natural ventilation, also to install combined ventilation units.

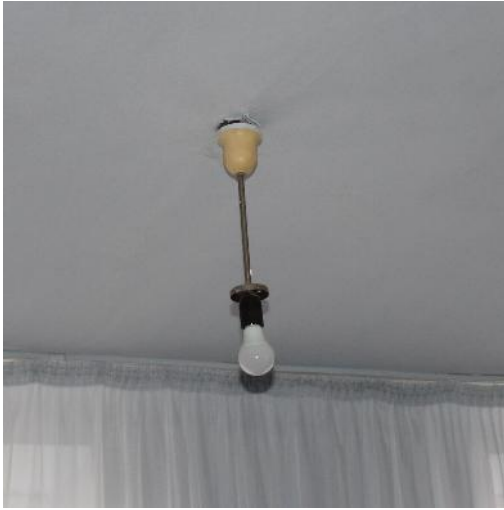
In block A, fluorescent lamps are used for lighting. The lighting level is low.

Photo 7 Lighting in classrooms

Lighting should be replaced in the entire building. LED lights are recommended. In the corridors, motion sensors should be installed in order to automatically turn off the lighting in the absence of movements.
